Contract #: 04-0120F4Cty: SF/ALA Rte: 80 PM: 13.2/13.9File #: 69.28**WELDING INSPECTION REPORT****Resident Engineer:**Pursell, Gary**Address:** 333 Burma Road**City:** Oakland, CA 94607**Report No:** WIR-015598**Date Inspected:** 08-Jul-2010**Project Name:** SAS Superstructure**OSM Arrival Time:** 700**Prime Contractor:** American Bridge/Fluor Enterprises, a JV**OSM Departure Time:** 1900**Contractor:** Zhenhua Port Machinery Company, Ltd (ZPMC), Changxing Island **Location:** Shanghai, China**CWI Name:****CWI Present:****Yes No****Inspected CWI report:** **Yes No N/A****Rod Oven in Use:** **Yes No N/A****Electrode to specification:** **Yes No N/A****Weld Procedures Followed:** **Yes No N/A****Qualified Welders:** **Yes No N/A****Verified Joint Fit-up:** **Yes No N/A****Approved Drawings:** **Yes No N/A****Approved WPS:** **Yes No N/A****Delayed / Cancelled:** **Yes No N/A****Bridge No:** 34-0006**Component:** Trial Assembly, Bay 4**Summary of Items Observed:**

## WELDING INSPECTION REPORT

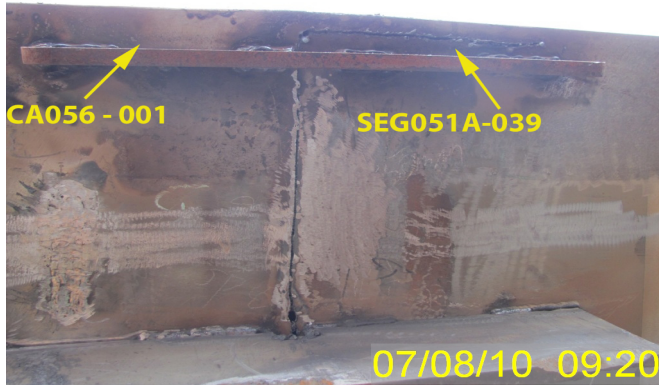
9 AW to 9BW EP to SP CB side

QA Inspector received verification request to perform Ultrasonic Testing (UT) members identified as the weld between Edge panel and side panel (Cross Beam side) of OBG segment 9AW and 9BW. The weld designations are as follows

QA Inspector was unable to perform UT on this weld as the weld was cut to rectify misalignment between 9AW to 9 BW Side plate

See picture for more information
